## GREENING OF THE KUDAWA WATHURANA ACCESS ROAD<sup>1</sup>

**Background.** The Sinharaja is one of Sri Lanka's last remaining rain forests. An access of 1.6 Km provides entry to the core conservation zone. This road was originally built several decades ago (in the 1970s) to facilitate transport of timber logs when commercial logging was allowed inside Sinharaja. In 2018, the road was rehabilitated by the Forest Department in order to promote Nature Based Tourism. The works included:

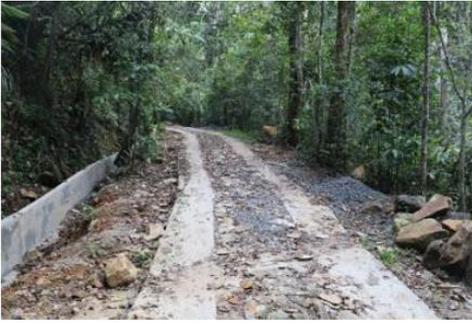
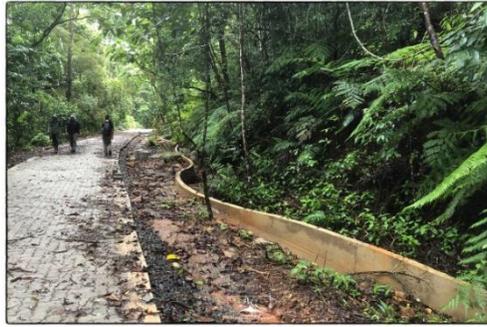
**Habitat fragmentation.** Although the width of the road and the expected level of traffic would not represent a barrier to fauna movement across the road, the type and depth of the concrete drains would obstruct the movement of small animals (lizards, amphibian, crawling insects) and most probably become traps. Small animals will not have the ability to get out of the ditch and be drowned or starve.

### Side drains become barrier to small fauna movement.

Although based on the pictures provided it would be difficult to find options to minimize this impact it is recommended that some measure to minimize this impact, design engineers can be requested to provide alternative solutions. Compacted shoulders, wooden planks could be used to provide passage to animals in some sections of the road.

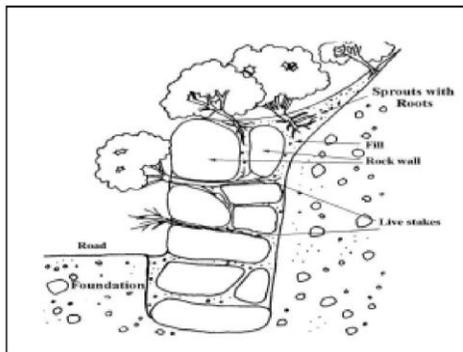
### A Wall with Live Stakes Constructed with Rock or Gabions and Vegetation

**Erosion control and Slope stabilization.** The proposed engineering measures are sound and will provide this protection along the road. However, it is encouraged that **Biotechnical Erosion Control** be used instead of only structural measures. Biotechnical Erosion Control consists of a combination of vegetative and structural measures used to prevent erosion or stabilize slopes and stream banks. The term “biotechnical” describes several methods of establishing vegetative cover by embedding a combination of live, dormant, and/or decaying plant material in a structure-like manner or in conjunction with riprap or physical structures such as cribs or gabions.

These measures would provide a more “nature based” look to the road. Some of the measures that could be used in this road include:

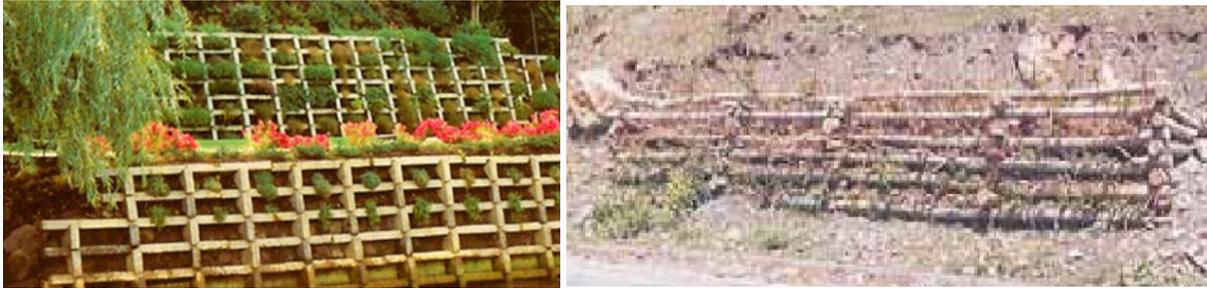
### Concrete and Wooden Crib Walls

Other alternatives include:

- Vegetated soft gabions
- Vegetated concrete crib walls

- Vegetated wooden crib walls

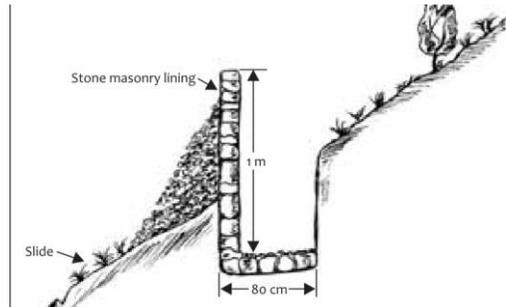
The proposed cut off drains at the top of the slopes are adequate. The cutoff drains are essential for preventing the additional runoff from the up slope to enter into the face of the slope.

### Cutoff Drain

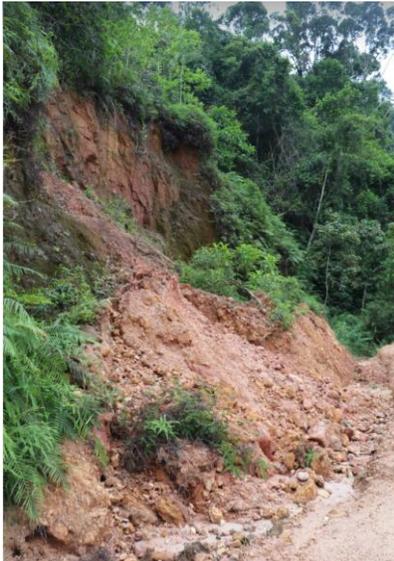
### Bioengineering is recommended for all slopes

Terracing is proposed in some high cuts like the one at 200 – 250 m from the entrance. Care should be taken to minimize the affectation of additional forest from this terracing. Vegetated concrete or wooden crib walls is recommended at this site and other high cuts. Vegetated gabions in the smaller cuts. Cut off drain is also needed.

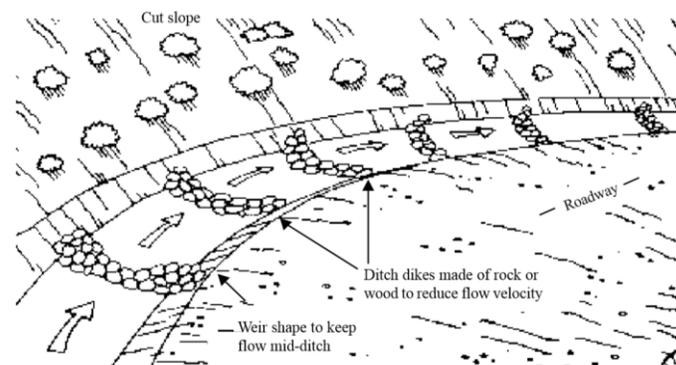
Ditches in steep grades in erosive soils, and with flow velocities over one meter per second may require armoring or the use of small ditch dike or dam structures placed in the ditch to slow down the velocity of water. The proposed rubble masonry drain, with cascading bottom is also adequate for this purpose.

### Ditch armoring

In areas without any ditch construction, an effort must be made for the ditches to be made to look more “natural, with perhaps a “V construction and armored with a turf reinforcing mat and grass (rather than concrete). In addition, it is recommended to look for opportunities for more frequent lead-offs (depending on road grades).

The outlet of pipes and ditches are ideally located in a stable, nonerosive soil area or in a well-vegetated or rocky area. The accelerated velocity of water leaving a roadway can cause severe erosion or gulying if discharged directly onto erosive soils. The pipes and drain outlet area can be stabilized, and the energy of the water dissipated, by discharging the water onto 1-2 cubic meters of a graded rock riprap.
